**LETTER REPORT
FOR
WENTWORTH MERCURY SPILL
CHICAGO, COOK COUNTY, ILLINOIS
TDD: S05-0010-018
PAN: 0C1801RZXX**

Re: Wentworth Mercury Spill
Chicago, Cook County, Illinois
TDD: S05-0010-018
PAN: 0C1801RZXX

**UNITED STATES ENVIRONMENTAL PROTECTION AGENCY
POLLUTION REPORT**

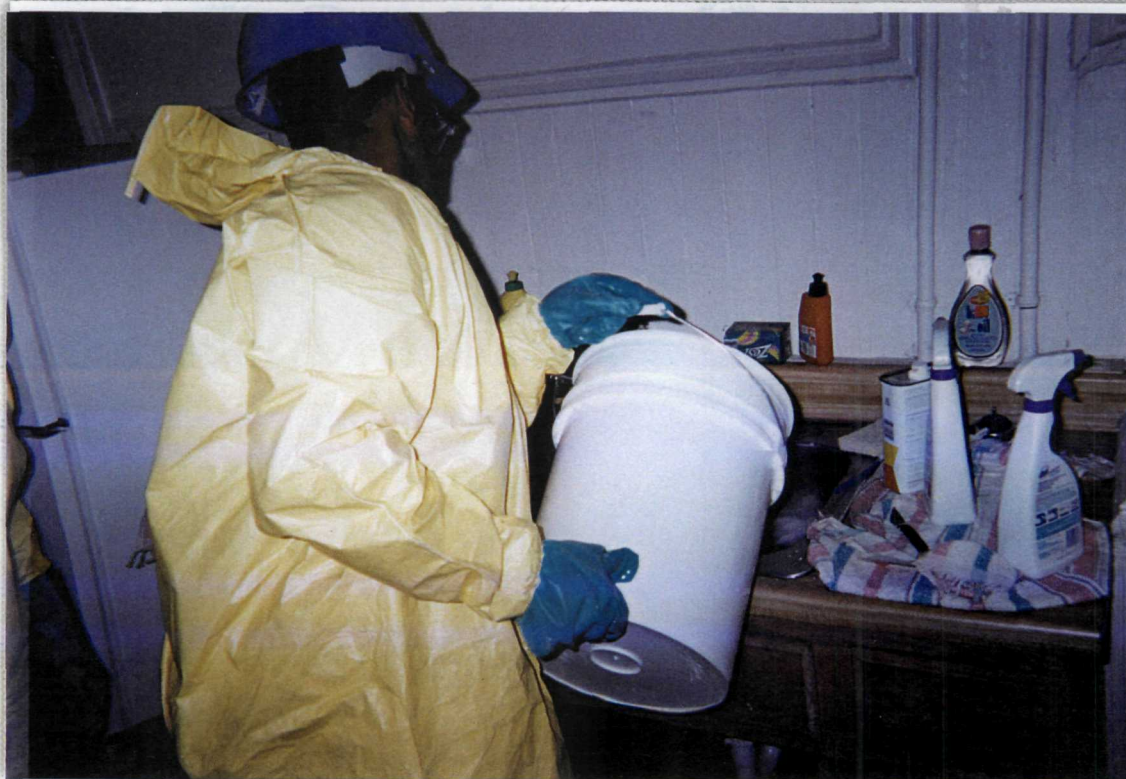
Site: Wentworth Mercury Spill
Location: Chicago, IL
Subject: View of ERRS pouring HgX solution into kitchen drain.

Based on the air monitoring data, OSC Simes requested that START perform a limited cleanup by using an HgX solution and pouring the solution into drain D-2. Readings of drain D-2 did drop after this action was taken; however, readings taken throughout the home indicated that a mercury source in the drainage system was still present. OSC Simms informed START that he would schedule the U.S. EPA Emergency and Rapid Response Services (ERRS) contractor for complete cleanup and removal of the mercury contamination in the home at a latter date. At approximately 1235 hours, the OSC and START left the site

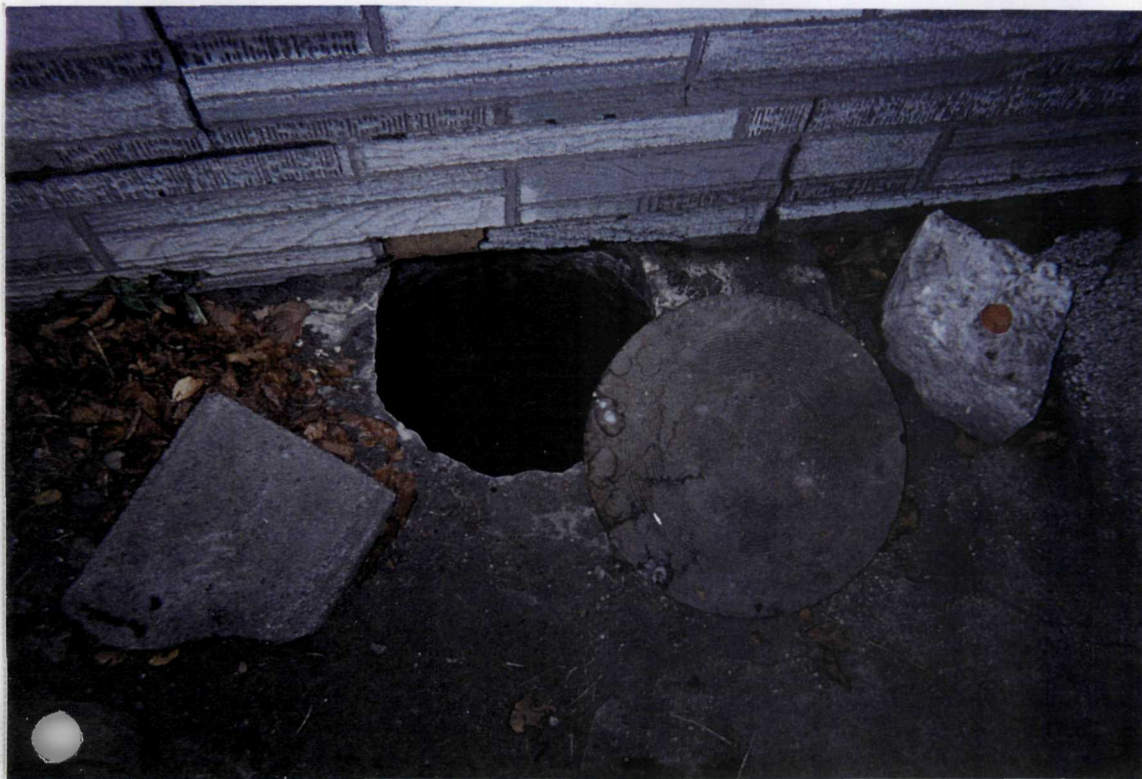
Site: Wentworth Mercury Spill
Location: Chicago, IL
Subject: View of catch basin.

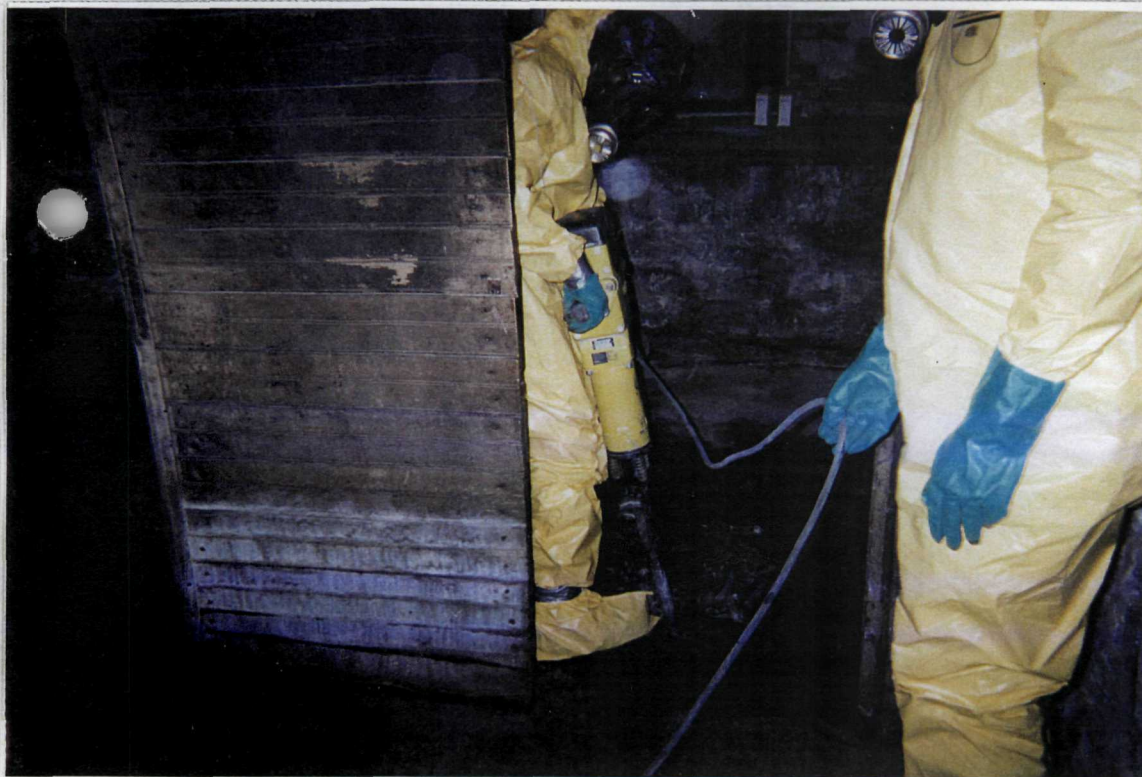
Site: Wentworth Mercury Spill
Location: Chicago, IL
Subject: View of ERRS using an electric jack-hammer to remove a portion of the basement drainage system.

On November 2 and 3, 2000, the OSC, START, and ERRS returned to the site to continue cleanup activities. On November 2, 2000, ERRS used an electric jack hammer to break D-2 out of the concrete floor and to remove related drain tile. As the drain tile and associated surrounding backfill was removed, START observed that Lumex® readings began to fall. On November 3, 2000, ERRS continued to remove drain tile and fill material. When approximately 10 feet of drain tile had been removed, OSC Simes informed START that removal of the drain tile would be halted and ventilation of the basement would begin. Readings were still not found to be acceptable after ventilating the basement for approximately one hour. The OSC then discussed with START that the HgX might be interfering with the Lumex® readings and that the basement and drain should be allowed to air-out over the weekend. All personnel left the site and returned on November 6, 2000.

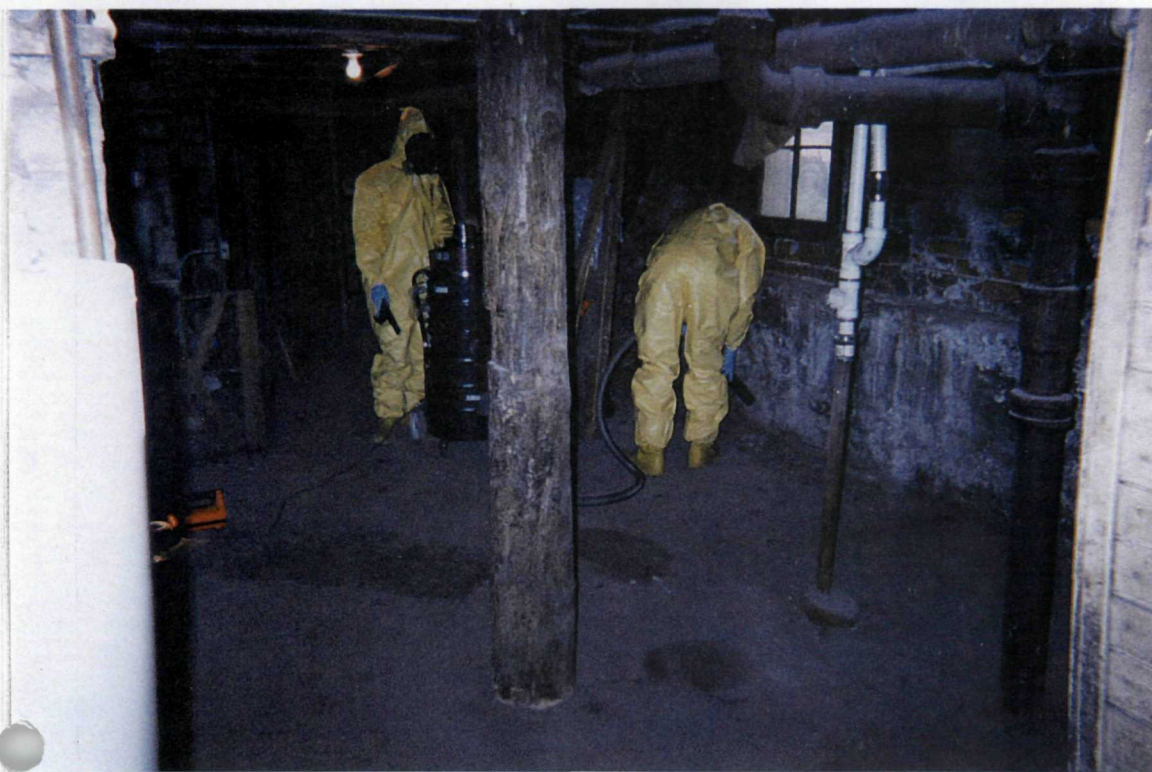
Subject: View of ERRS using a mercury vacuum to clean basement.

On November 1, 2000, OSC Simms, START Reuscher, and ERRS contractor Ferguson Harbor, Inc. mobilized to the site to begin cleanup of the home. START conduct an initial walkthrough of the site using the Lumex® MVA. Readings ranged from 80 $\mu\text{g}/\text{m}^3$ on the second floor to 21,000 $\mu\text{g}/\text{m}^3$ at a pile of dust next to D-2. All drains were screened again and found to have readings from 714 $\mu\text{g}/\text{m}^3$ at the 1st floor bath tub to 112 $\mu\text{g}/\text{m}^3$ at the kitchen sink. OSC Simes instructed ERRS to clean and vacuum all basement rooms, pour an HgX solution into all drains in the home, and power-wash D-2 and the associated basement drainage system. All basement water drained to an outside catch basin where it was collected for disposal. ERRS continued to wash the drainage system; however, mercury vapor levels in the basement were not reduced to acceptable levels.

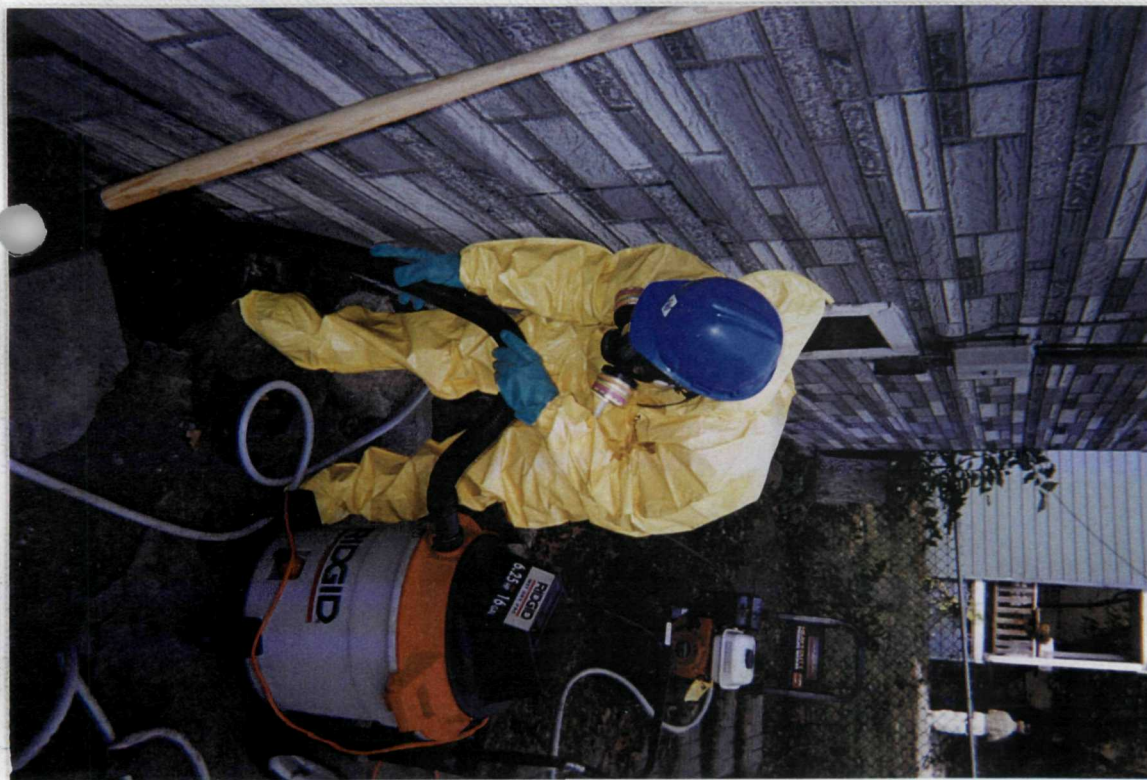
Subject: View of ERRS using a wet-vacuum to collect wash water from the drainage catch basin.

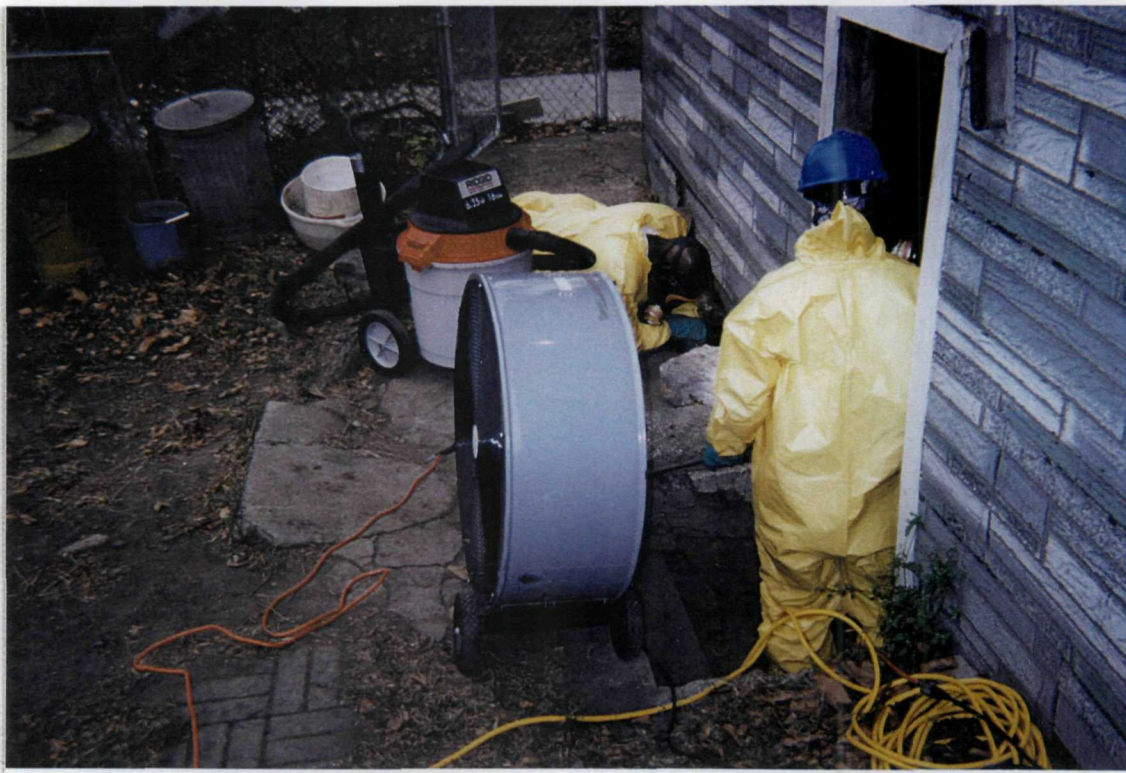
Site: Wentworth Mercury Spill
Location: Chicago, IL
Subject: View of venting procedures.

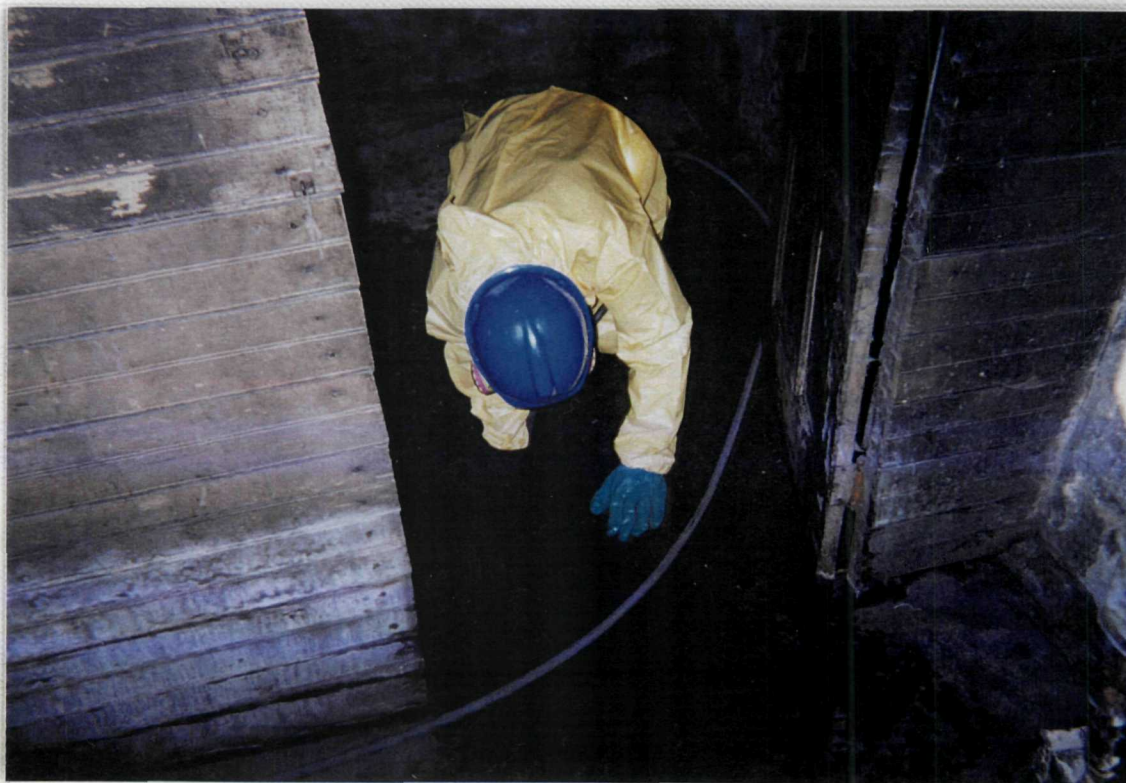
Site: Wentworth Mercury Spill
Location: Chicago, IL
Subject: View of ERRS power washing drainage system.

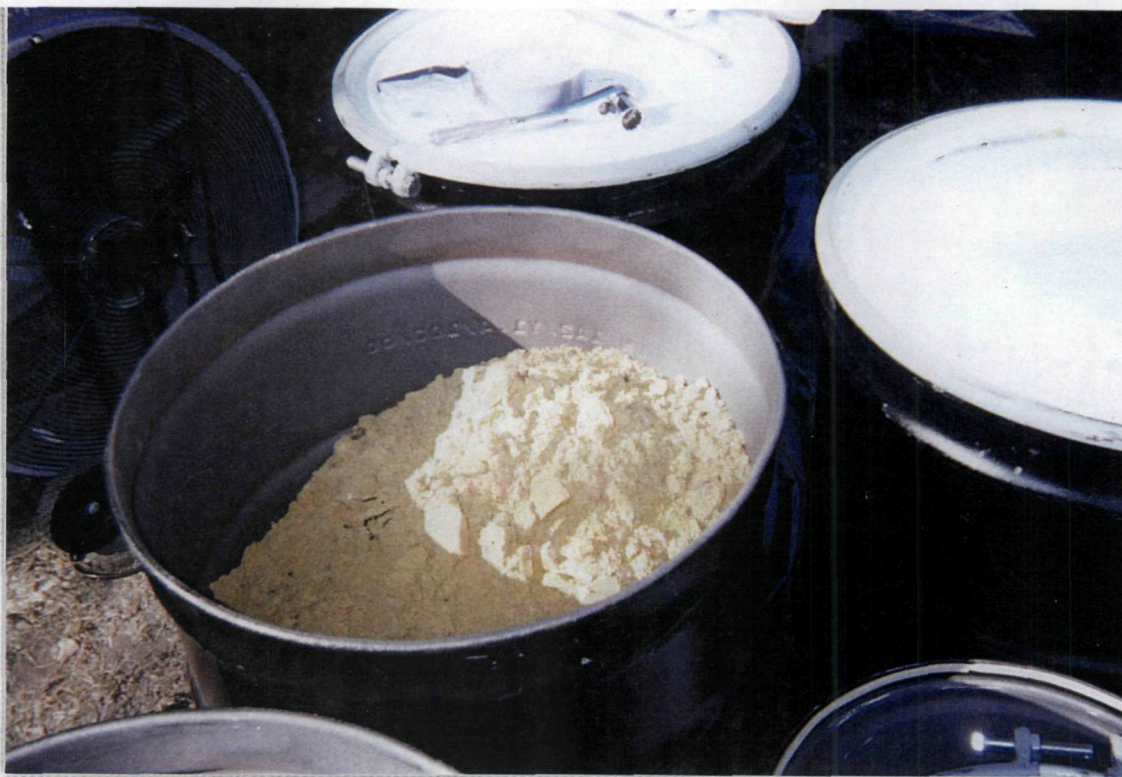
Subject: View of contaminated sand, removed from the basement excavation.

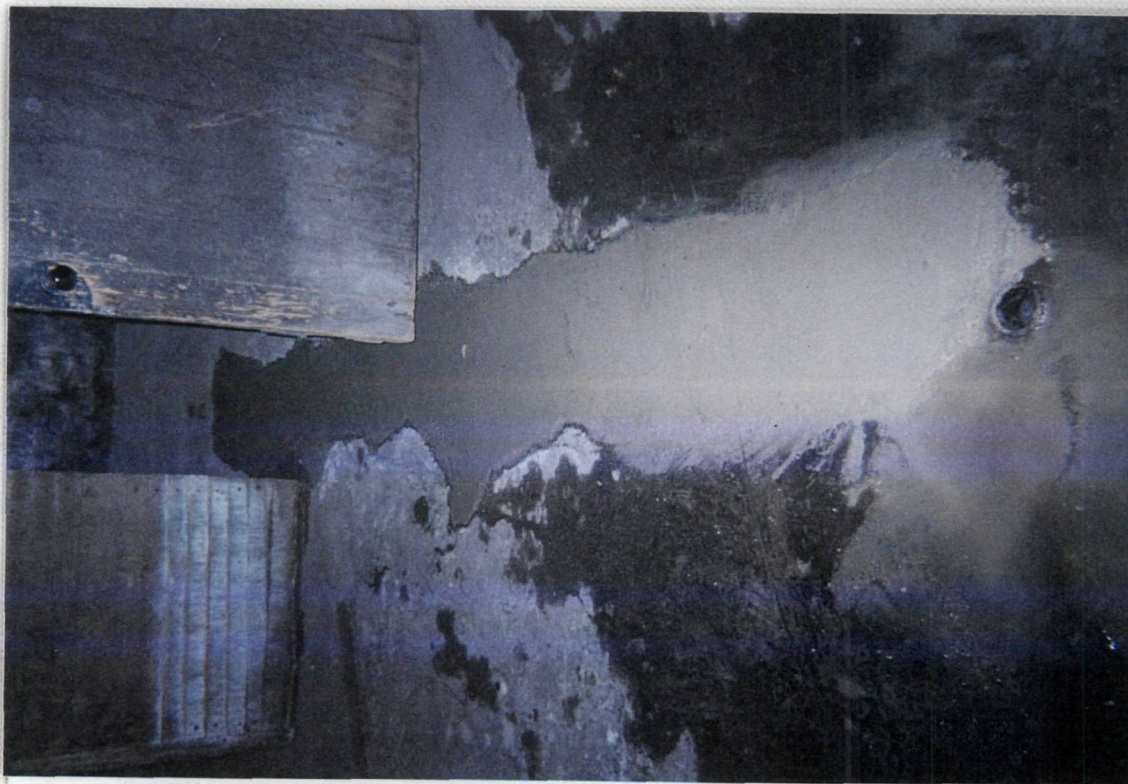
Subject: View of repaired excavation.

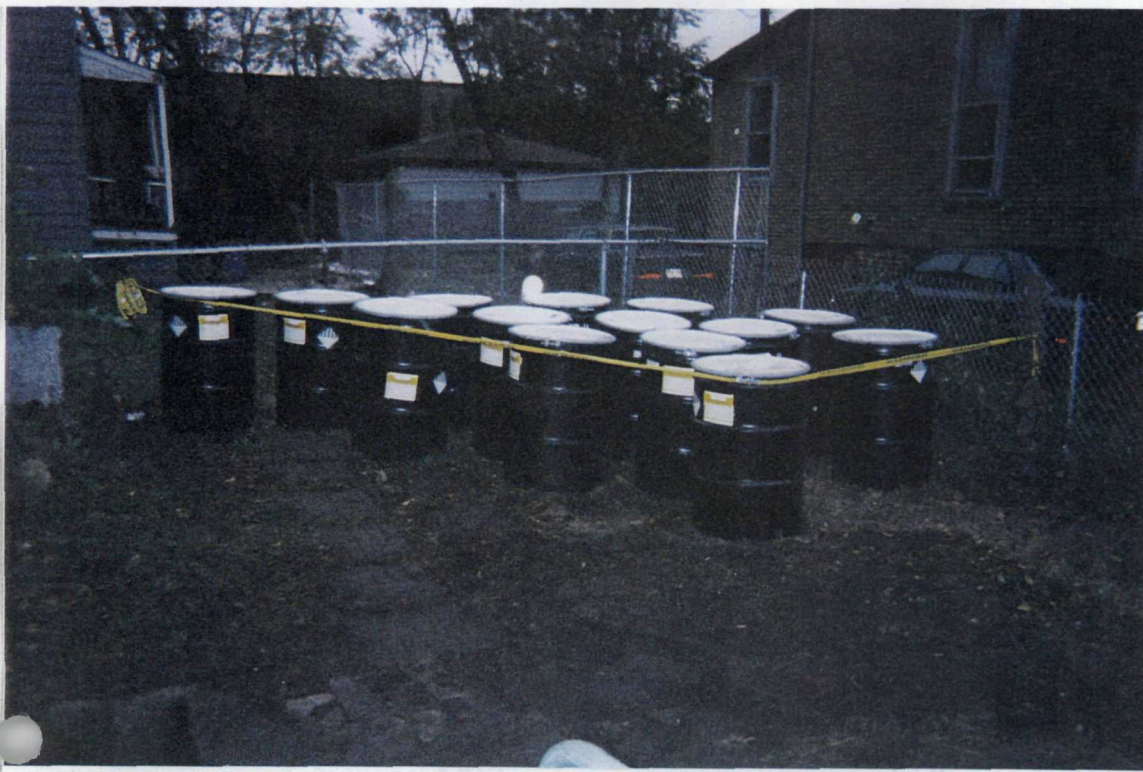
Subject: View of 55-gallon drums of mercury-contaminated waste.

Wastestream	Quantity	Date of Disposal	Disposal Facility
Mercury-contaminated soil and concrete	(13) 55-gallon drums	Not yet determined	Heritage Environmental, Inc.
Mercury-contaminated water	(2) 55-gallon drums	Not yet determined	Heritage Environmental, Inc.

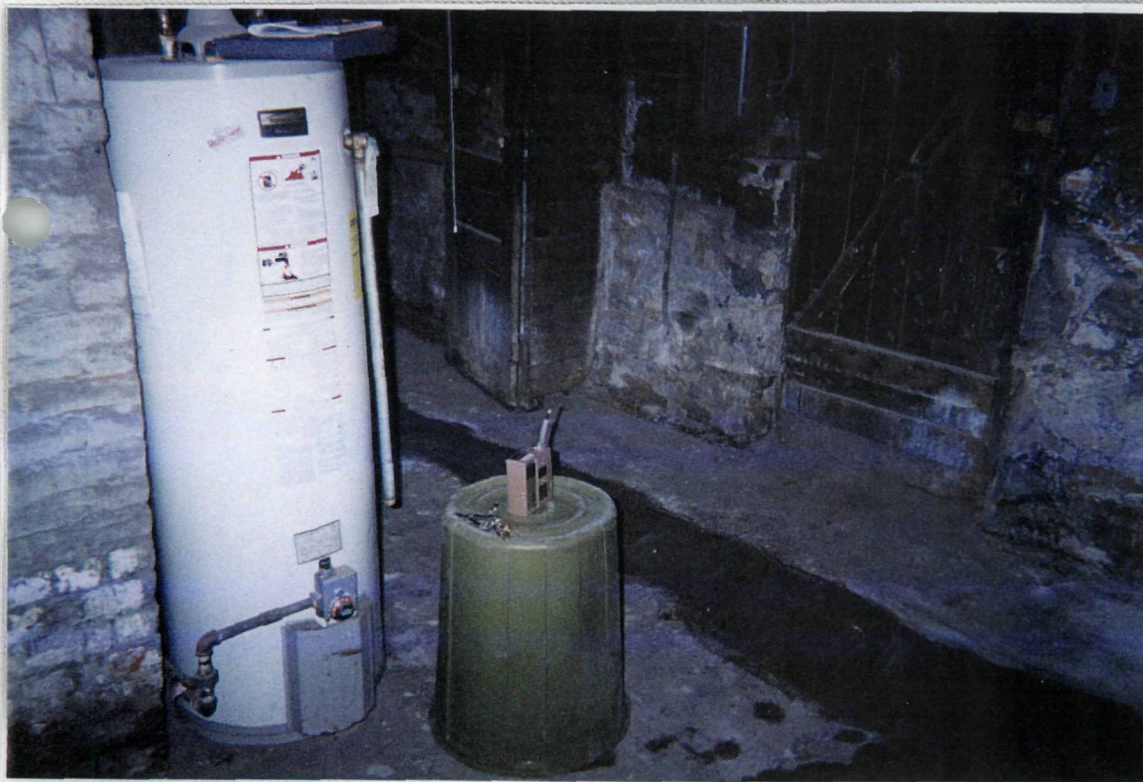
Subject: View of sample location S-1.

Table of mercury confirmation sampling results.		
Sample number	Location	Results (mg/m ³)
S-1	1 st Floor , center of room	0.00027
S-3	Blank	ND
S-4	2 nd floor, center of room	0.00032
S-5	Blank	ND
S-7	East end of basement	0.00053

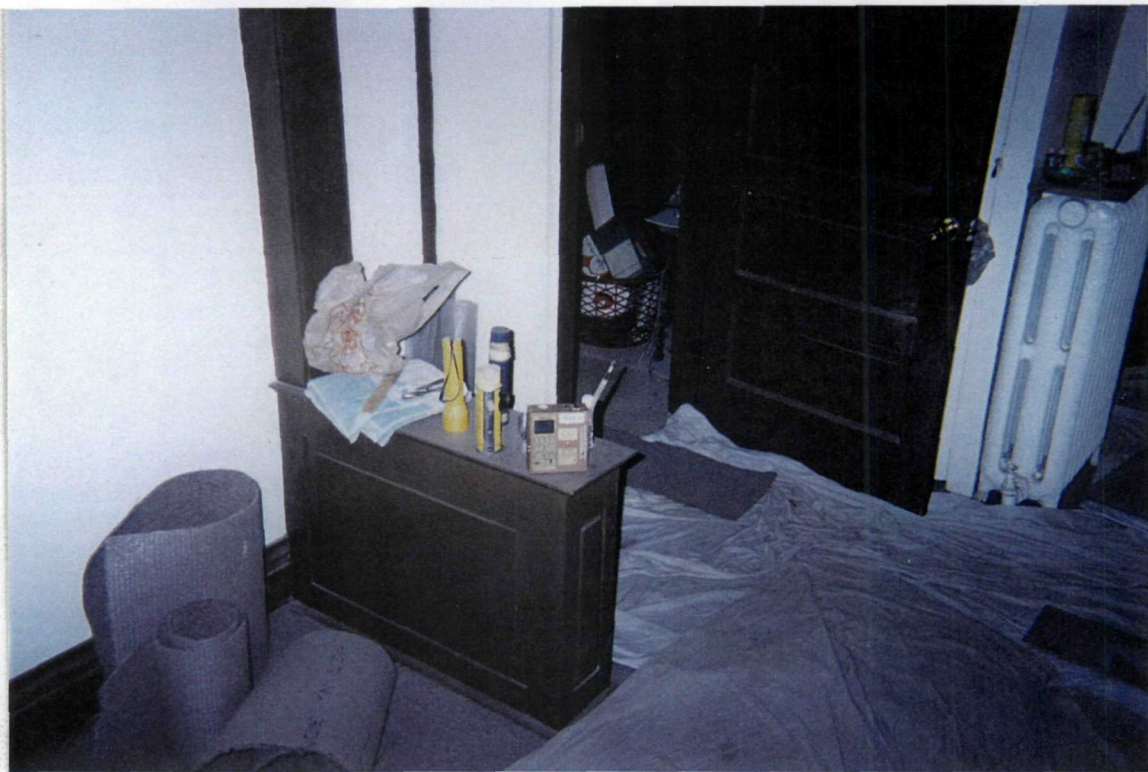
Site: Wentworth Mercury Spill
Location: Chicago, IL
Subject: View of sample location S-4.

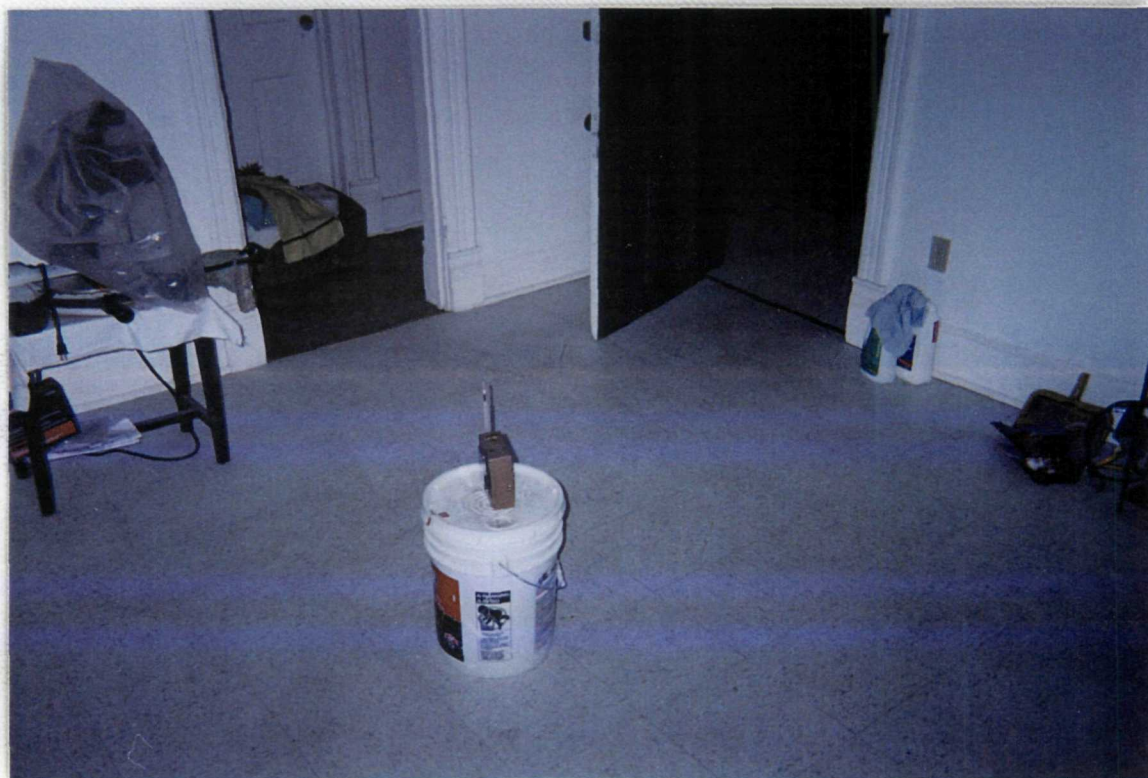
Site: Wentworth Mercury Spill
Location: Chicago, IL
Subject: View of sample location S-7.
